TECHNICAL NOTE

D-263

EFFECTS OF MELTING PRACTICE AND ALUMINUM COATING ON THE LIFE OF

GMR 235 BUCKETS OPERATED AT 1650° F IN A TURBOJET ENGINE

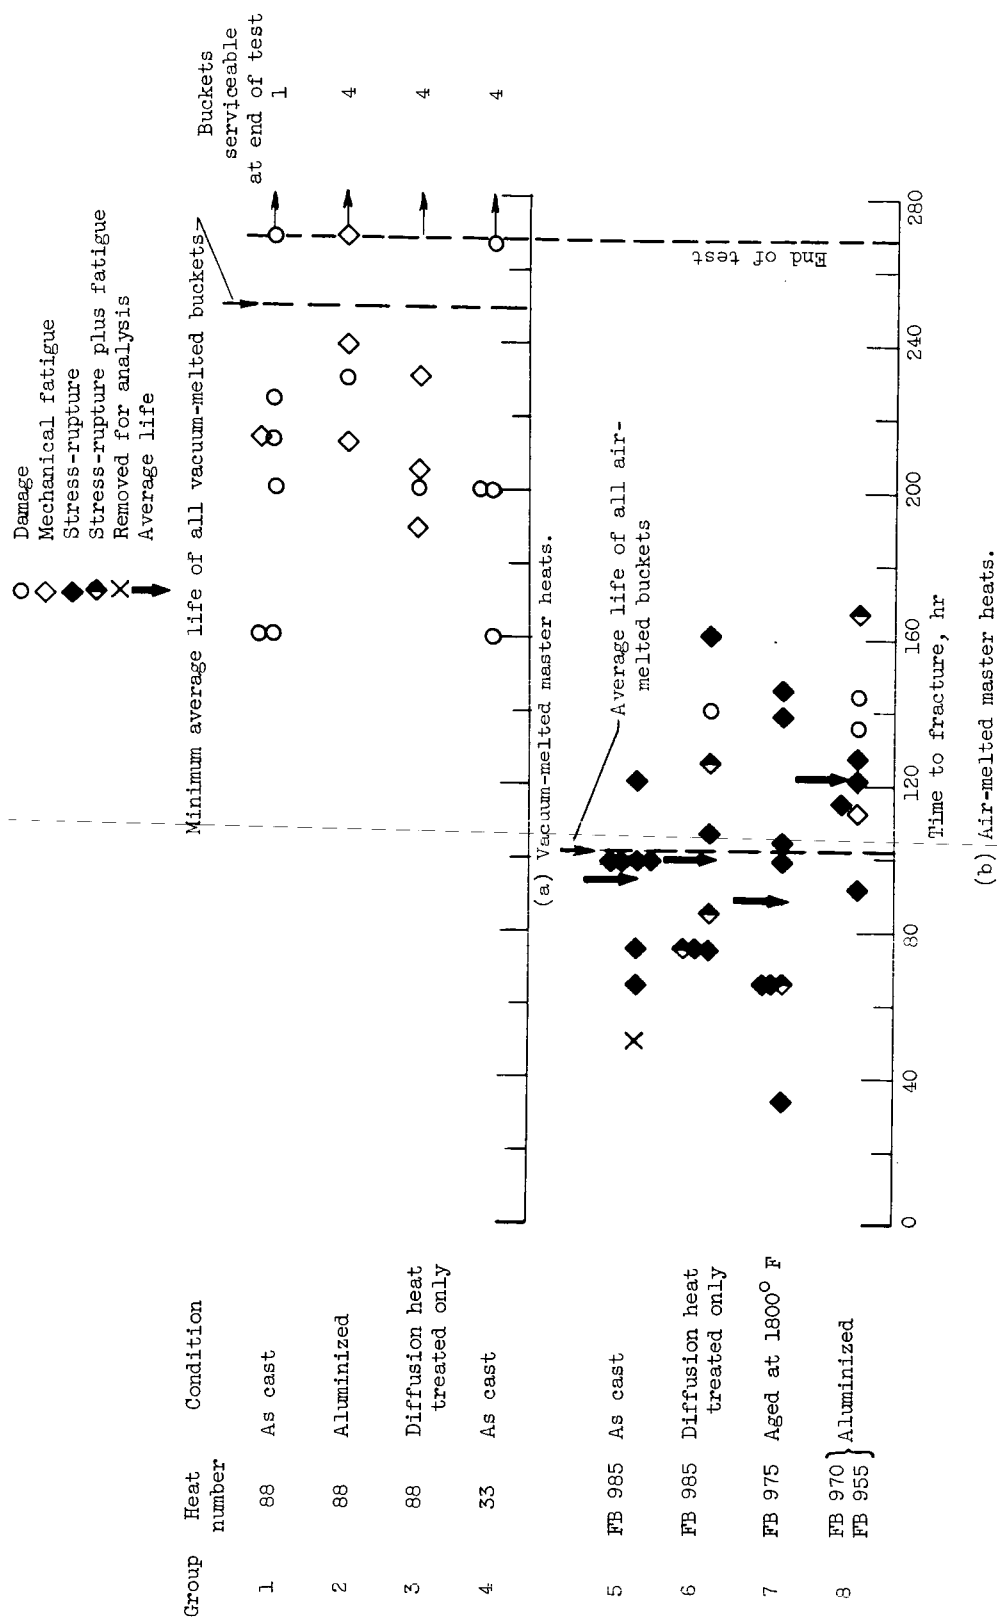
Figure 9. - Time to fracture of CMR 235 buckets in a J33-9 engine operating at 1650° F at rated speed (11,500 rpm).

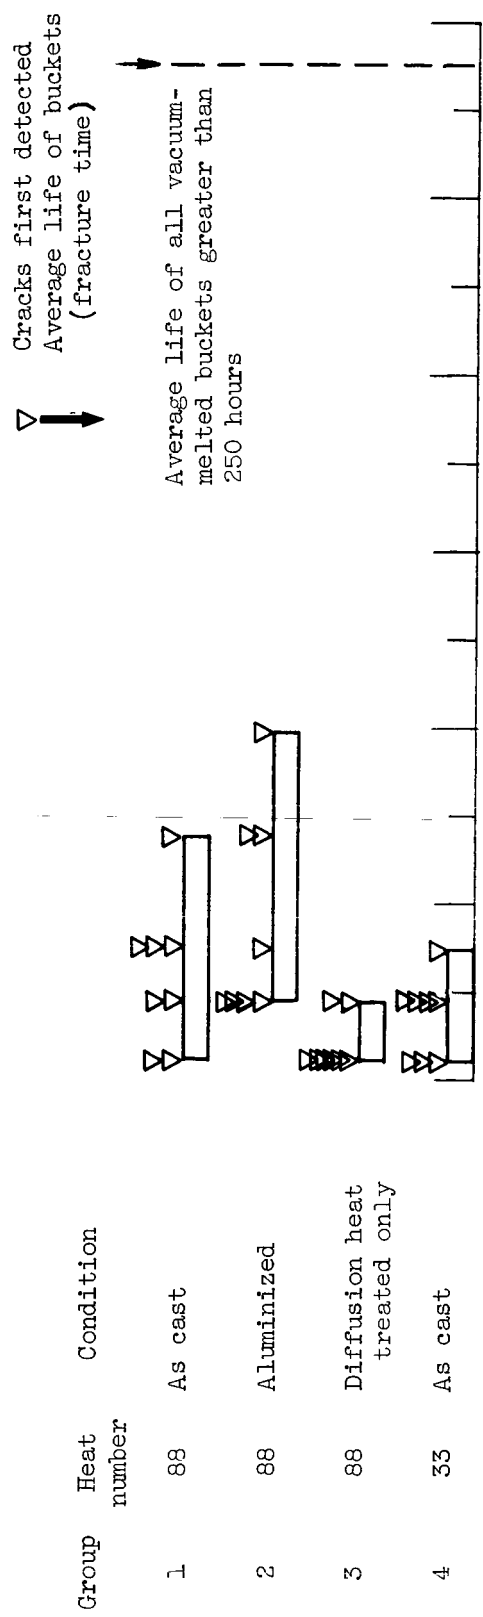
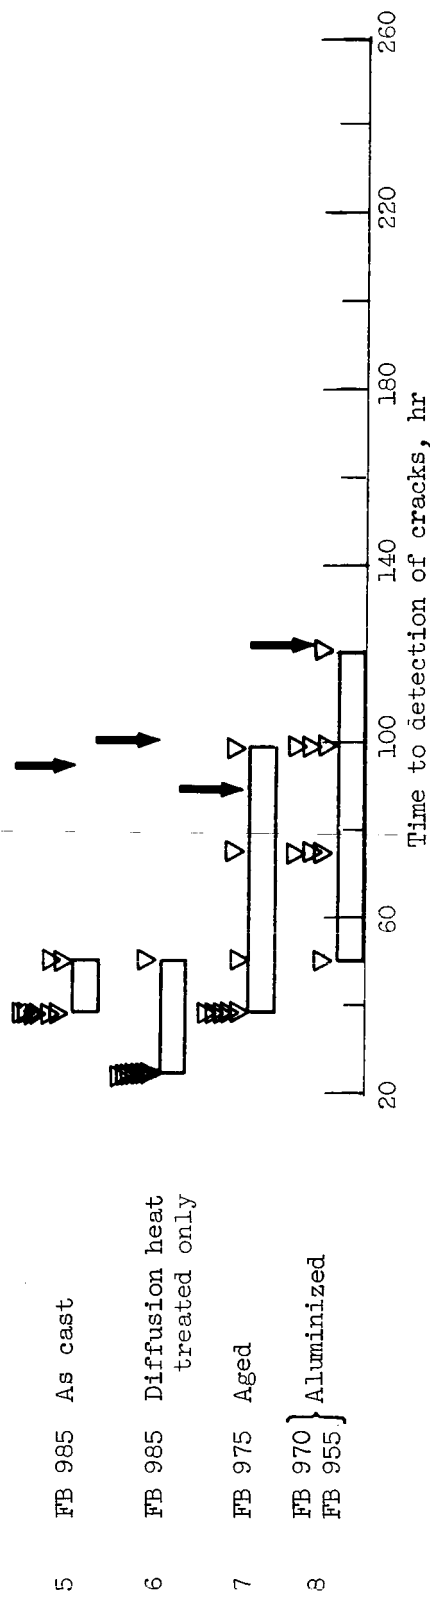
Figure 11 further indicates that the aluminized air-melted buckets had a better crack resistance than did the as-cast air-melted buckets. The aluminized buckets (group 8) had an average time to crack formation of 86 hours as compared with 41 hours for the as-cast material (group 5). It should be recalled that the aluminized buckets were from two heats which differed from the as-cast heat used for a basis of comparison. The diffusion-heat-treated air-melted buckets had a lesser crack resistance than did the as-cast buckets.

(a) Vacuum-melted master heats.

(b) Air-melted master heats.

Figure 11. - Occurrence of thermal-fatigue cracks in GMR 235 buckets operated at 1650° F in a J33-9 turbojet engine, relative to average time to fracture.

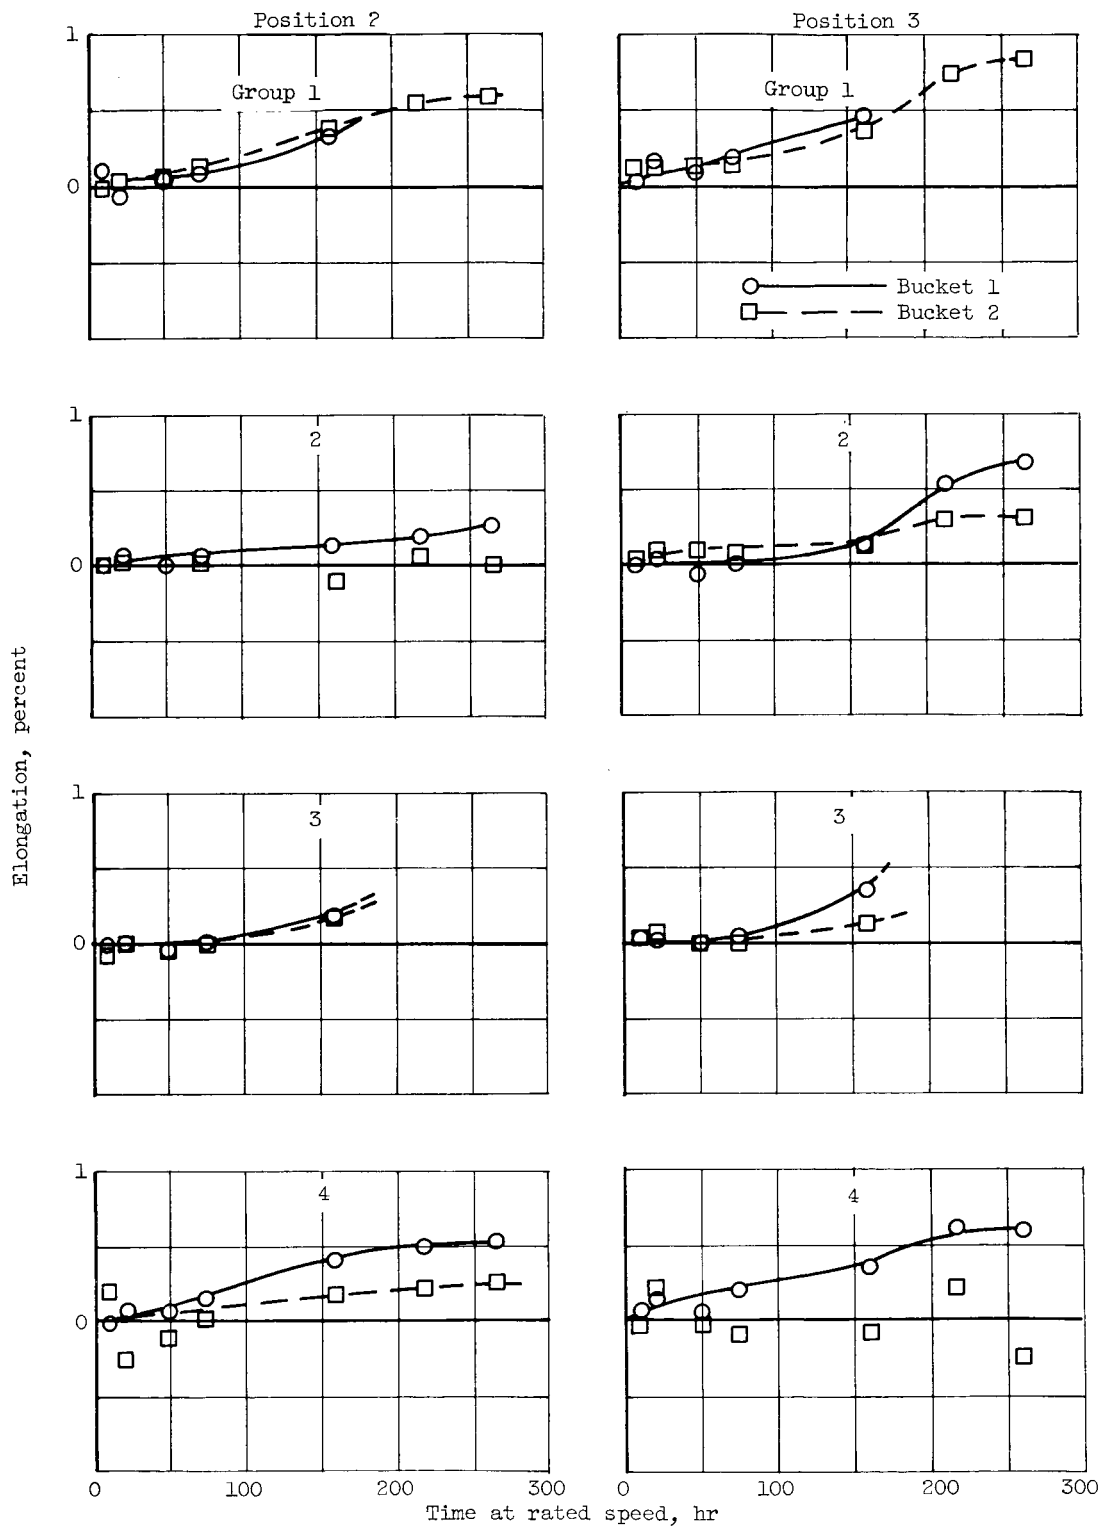
Bucket elongation during engine operation. - The percent elongations occurring in positions 2 ($1\frac{1}{2}$ to 2 in. above the base) and 3 (2 to $2\frac{1}{2}$ in. above the base) (see fig. 2 for positions) during rated-speed operation are plotted in figure 12 for buckets of groups 1 to 7. Positions 2 and 3 were selected because they are located near the critical zone of the buckets, where the combination of stress and temperature would be expected to cause plastic deformation to be most pronounced. The data show that the buckets generally exhibited rather low elongation. The maximum elongation was of the order of 1.2 percent and occurred in an air-melted bucket from group 7.

(a) Vacuum-melted buckets.

Figure 12. - Elongation of GMR 235 buckets during engine operation at 1650° F.

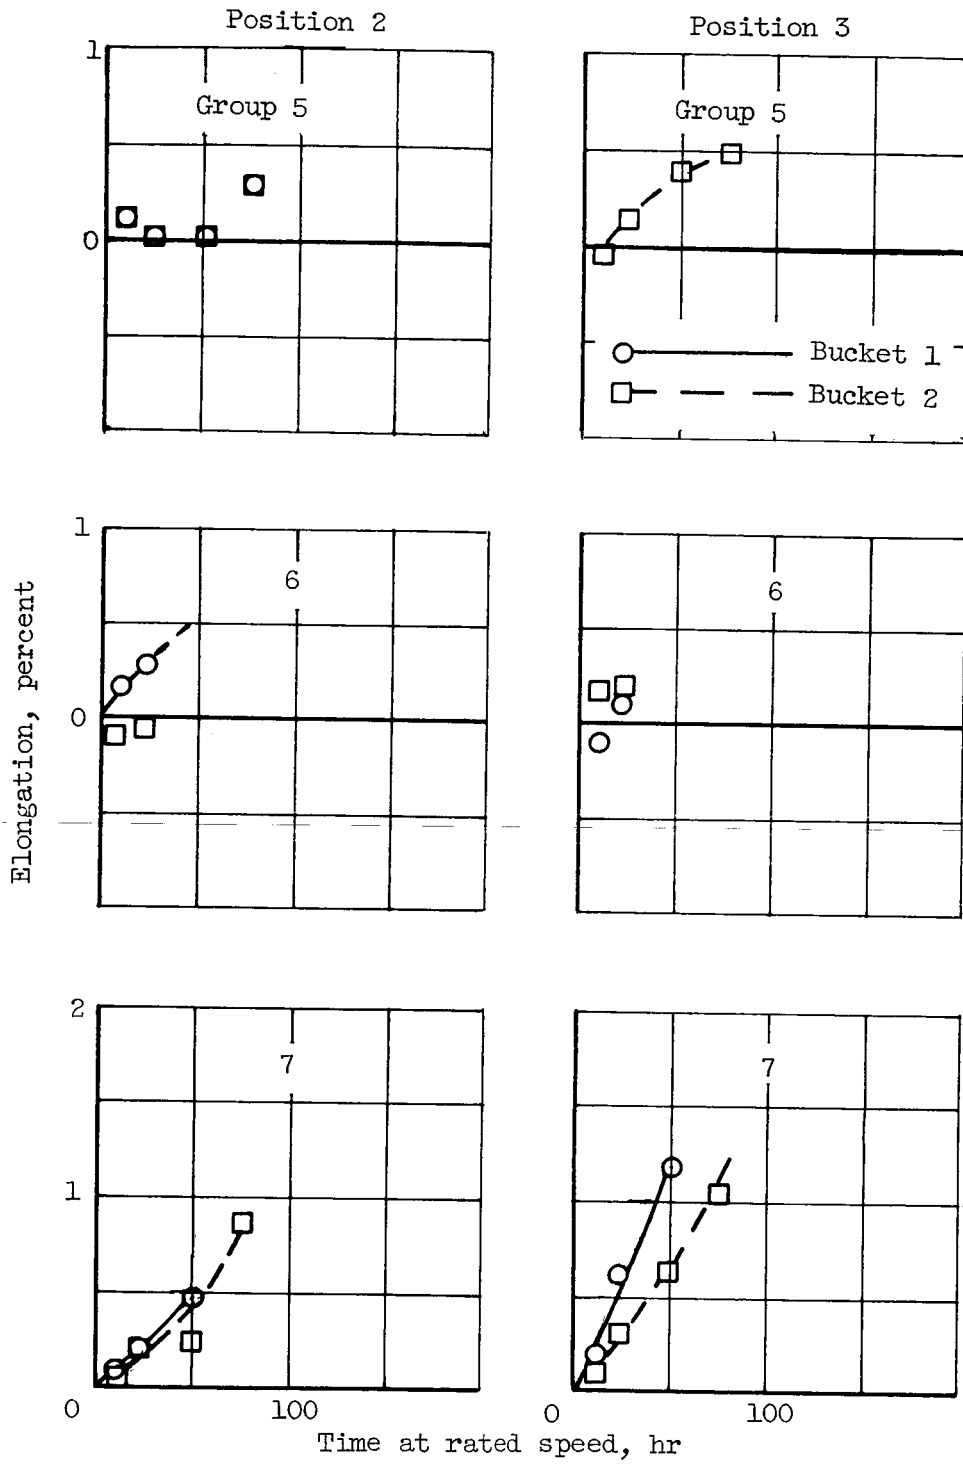
(b) Air-melted buckets.

Figure 12. - Concluded. Elongation of GMR 235 buckets during engine operation at 1650° F.

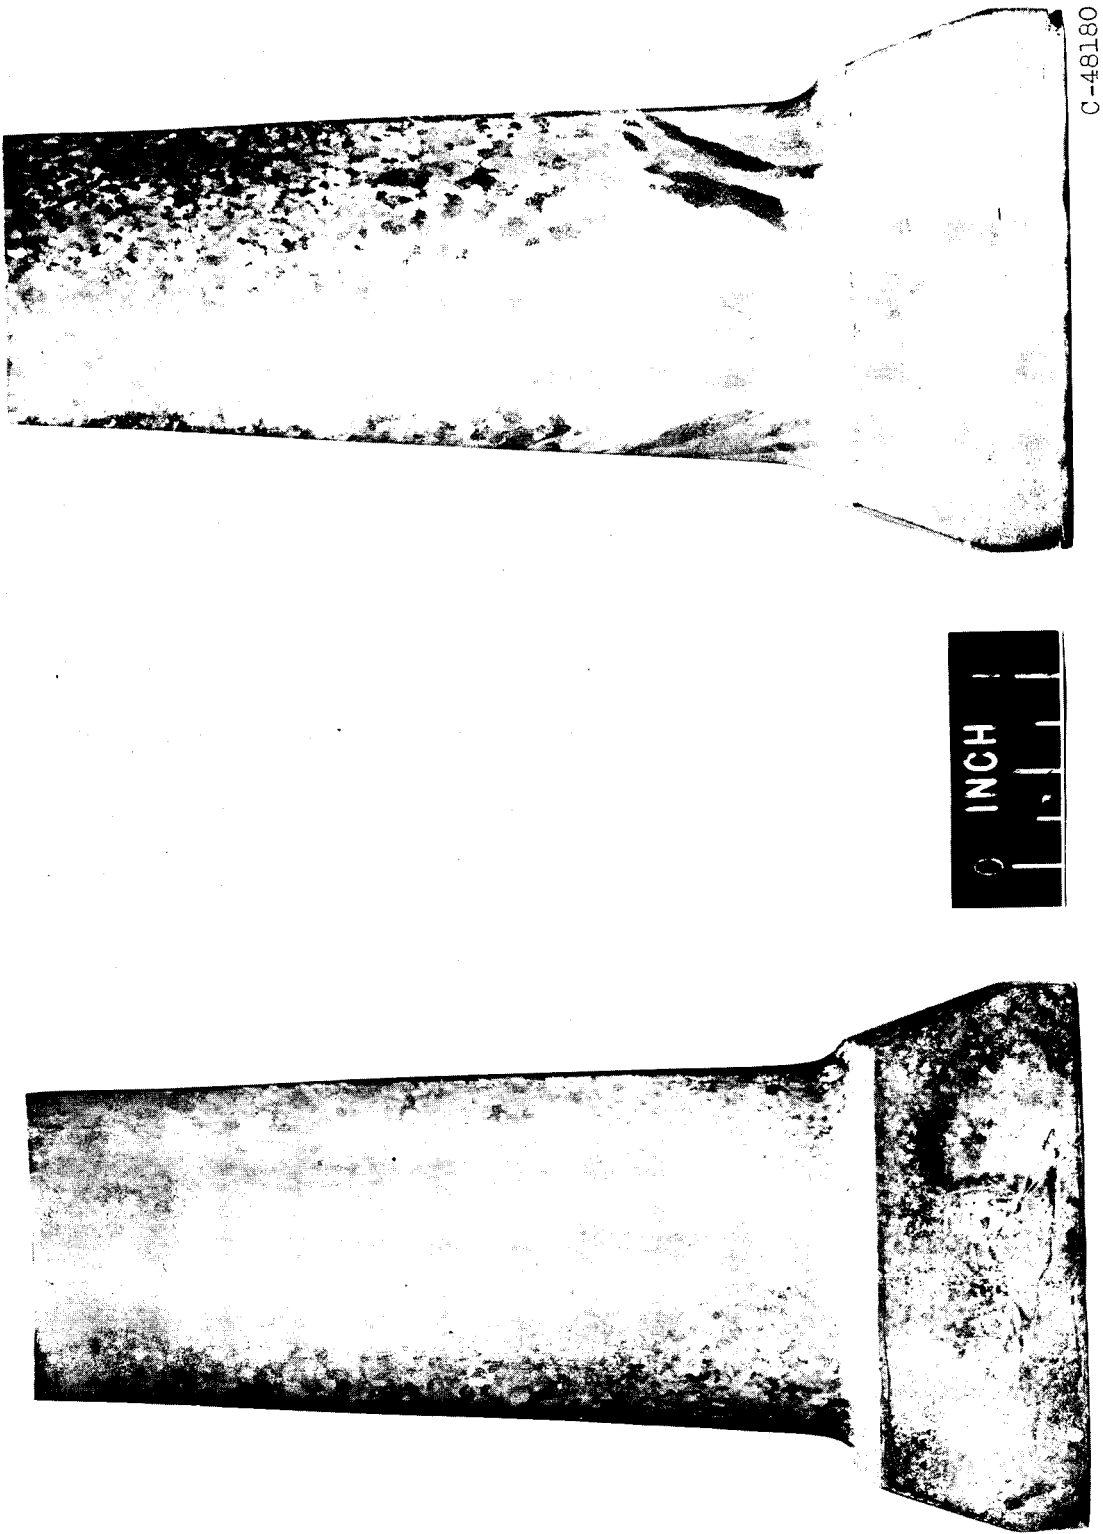
As-received buckets. - Examples of macrograins present in vacuum-melted and air-melted as-cast buckets (groups 1 and 5) are shown in figure 13. The grains of the vacuum-melted buckets were equiaxed and were uniformly fine throughout the airfoil. The grains of the air-melted buckets varied from equiaxed, uniformly fine grains in the upper two-thirds of the airfoil to columnar, medium-sized grains in the lower third of the bucket airfoil.

(a) Vacuum-melted bucket.

(b) Air-melted bucket.

Figure 13. - Macroetched as-cast buckets.

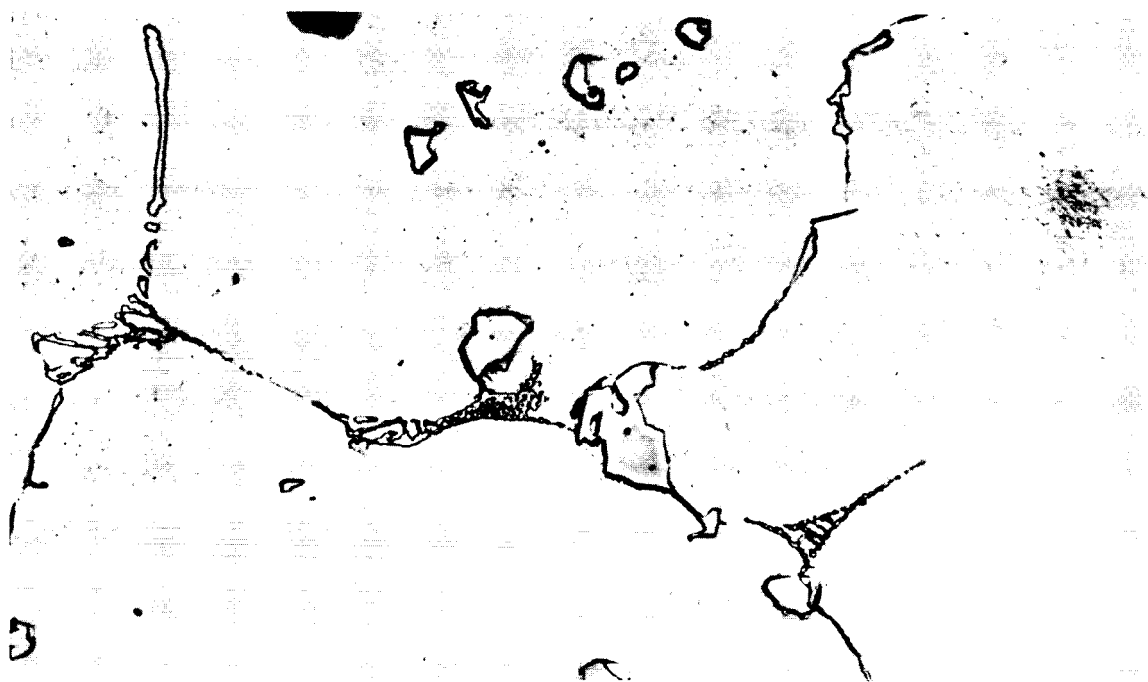
All buckets examined contained a "Chinese script" type of micro-constituent that has been determined to be a complex boride (ref. 5). The as-cast buckets, figures 14(a) and (c), contained some finely dispersed precipitates that may be Ni_3Al type intermetallic compounds, which are commonly present in high-nickel alloys containing aluminum (ref. 12). However, the aluminized GMR 235 buckets, figures 14(b) and (d), lacked the fine precipitate. The absence of fine precipitates in the photomicrographs of the aluminized buckets was attributed to solutioning by the diffusion heat treatment (2040°F for 3 hr). The heat treatment did not appear to alter appreciably the "Chinese script" type of precipitates. Figure 14(e) shows a representative microstructure of the aged (5 hr at 1800°F), air-melted buckets (group 7). The aging treatment also appears to have caused a slight amount of solutioning.

(a) As-cast vacuum-melted, group 1.

Figure 14. - Typical microstructures of as-received GMR 235 buckets.

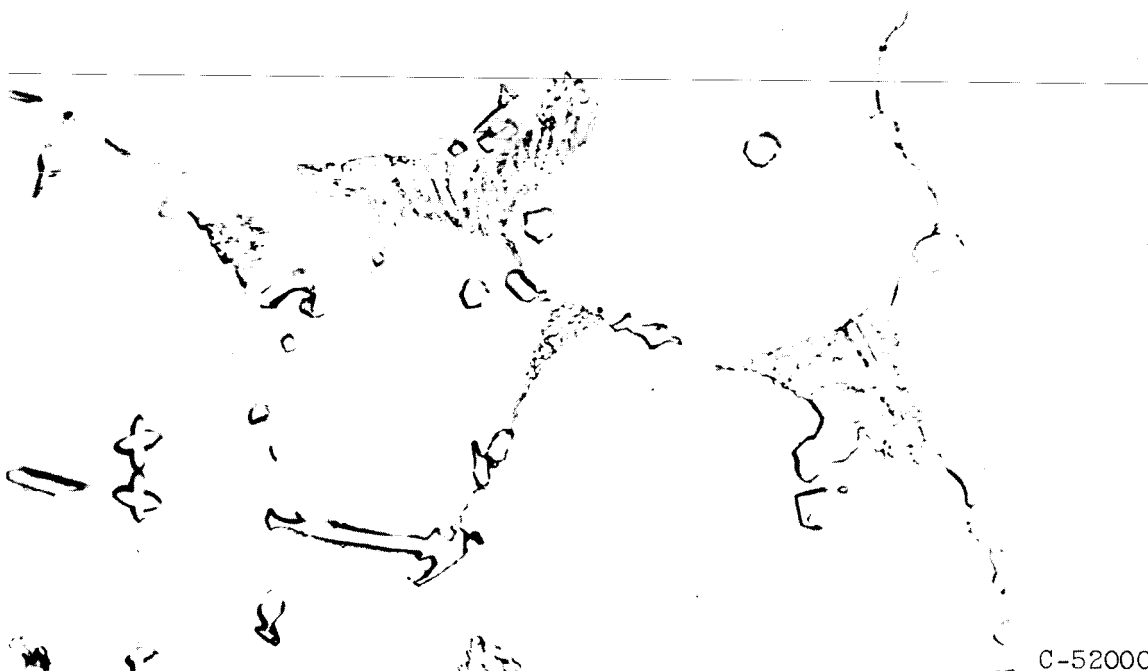
(b) Aluminized vacuum-melted, group 3.

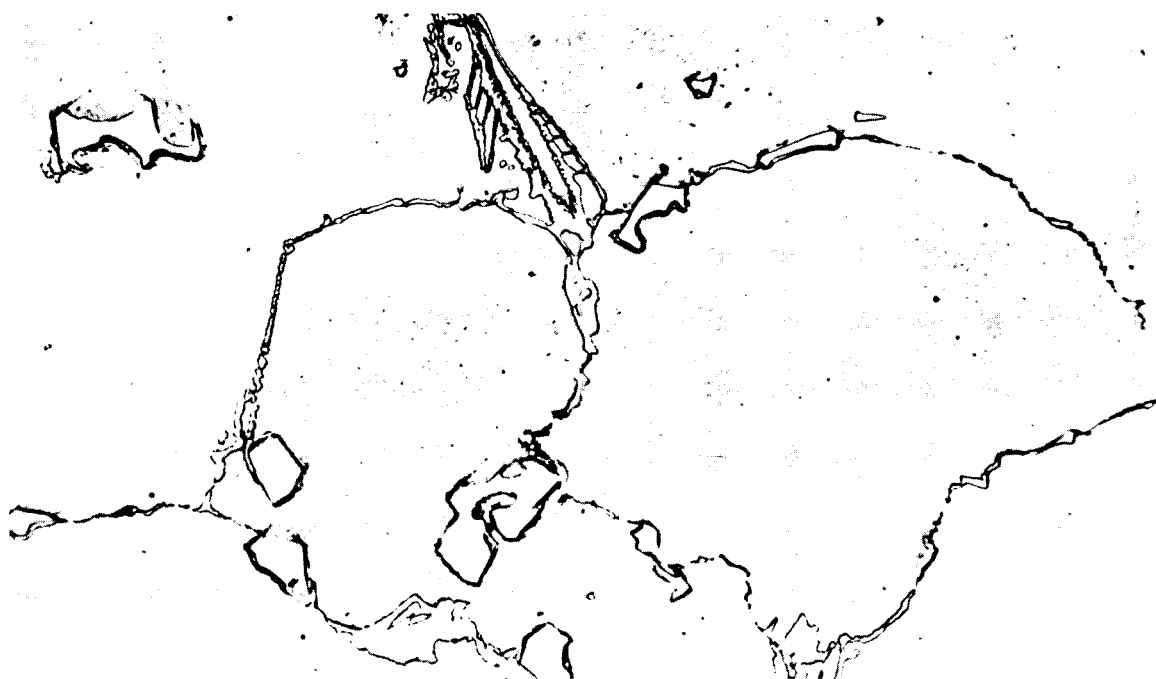
(c) As-cast air-melted, group 5.

Figure 14. - Continued. Typical microstructures of as-received GMR 235 buckets. Electrolytically etched in a 40 percent hydrochloric acid, 10 percent nitric acid, 50 percent distilled water solution; X750.

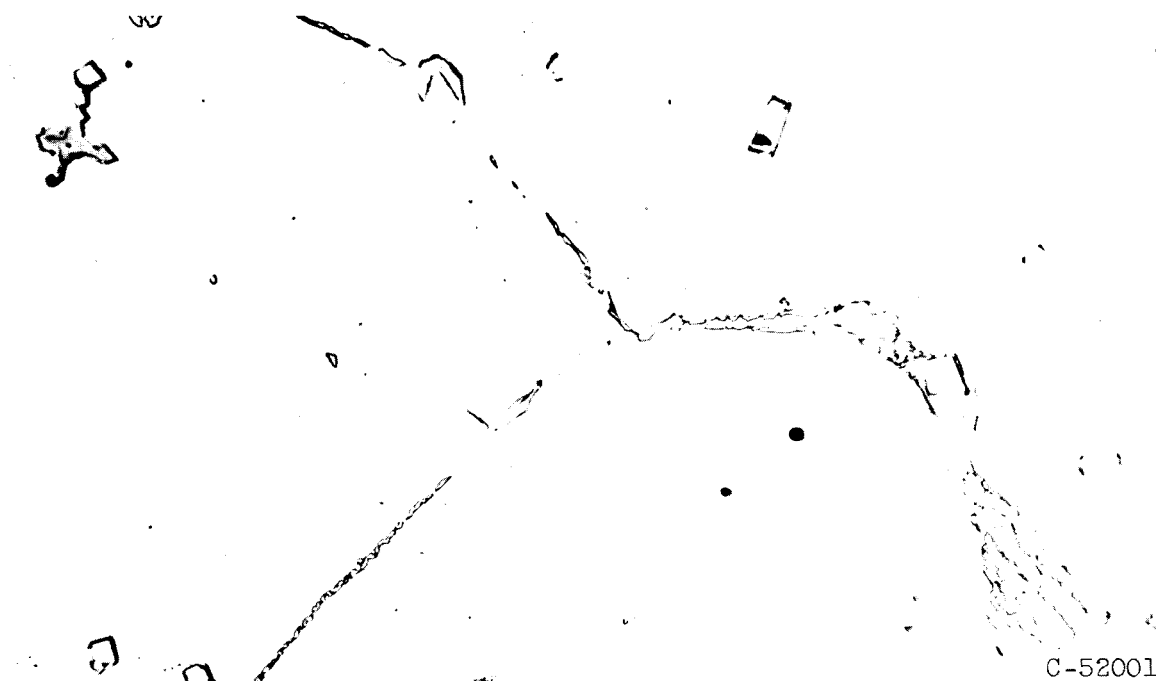
(d) Aluminized air-melted, group 8.

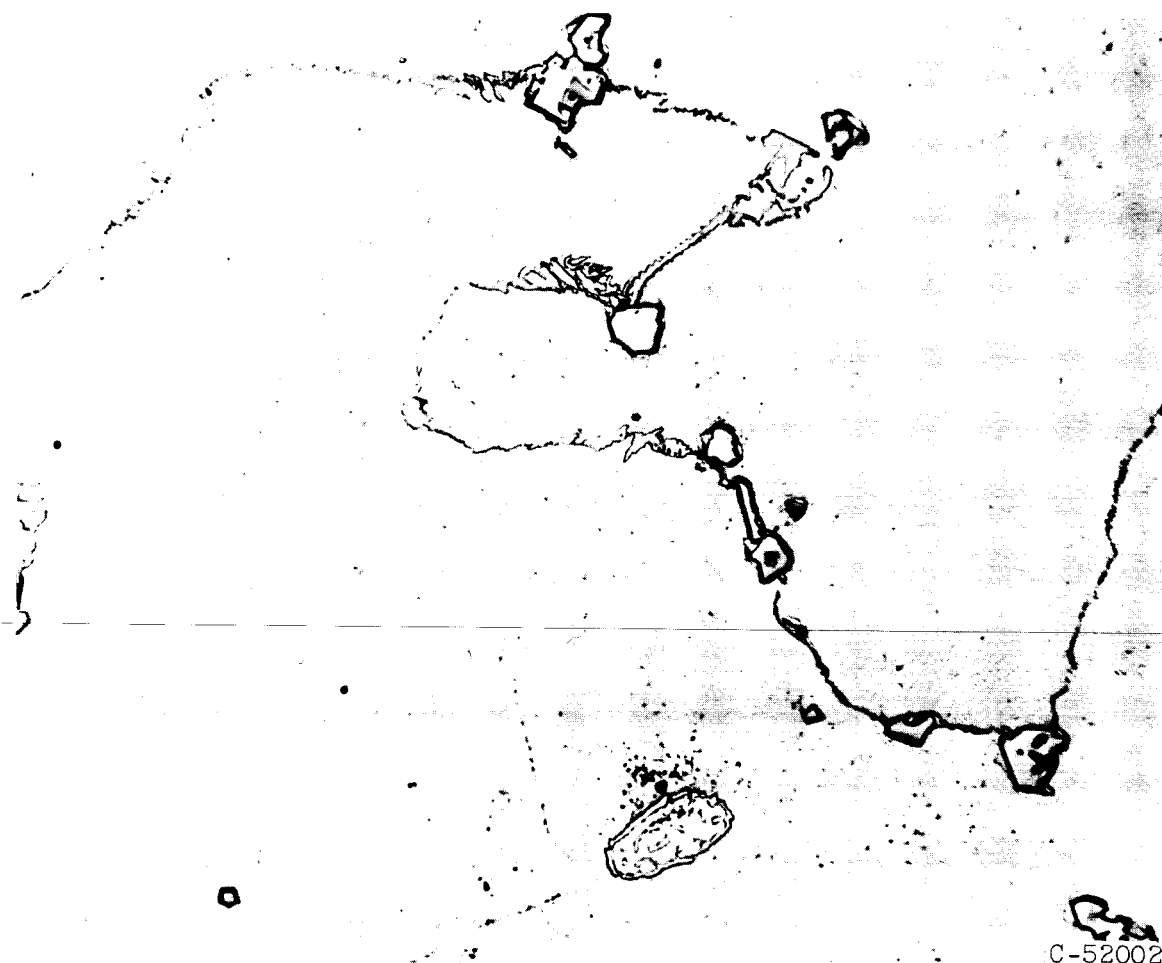
(e) Aged air-melted, group 7.

Figure 14. - Concluded. Typical microstructures of as-received GMR 235 buckets. Electrolytically etched in a 40 percent hydrochloric acid, 10 percent nitric acid, 50 percent distilled water solution; X750.

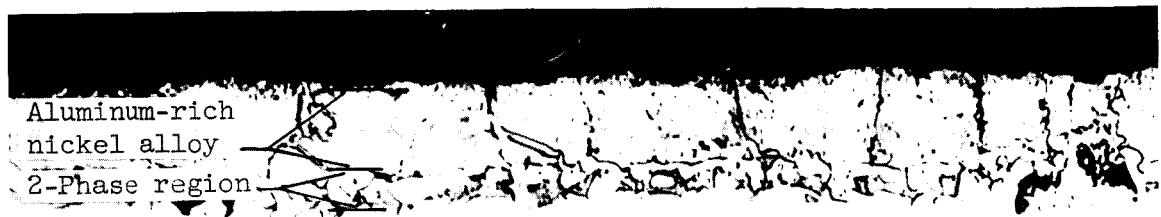
The microstructure of the "aluminum coating" consists of an outside envelope and a thin two-phase region at the GMR 235 matrix - aluminum-coating interface (fig. 15). A microhardness check of the coating showed the outside envelope to be equal in hardness to the matrix and the two-phase region to be appreciably harder. From these observations, it was concluded that the outside envelope was an aluminum-rich nickel alloy

Figure 15. - Microstructure of coating present on aluminized buckets. Swab-etched with a 3-part glycerine, 2-part nitric acid, 1-part hydrofluoric acid solution; X1000.

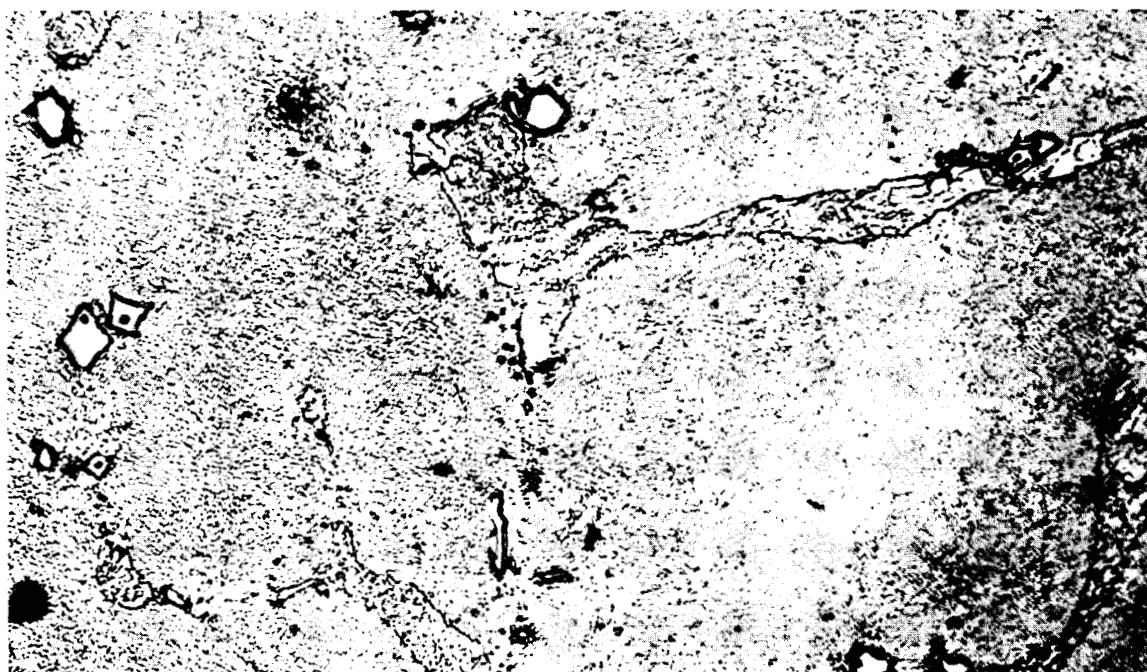
Operated buckets. - Metallographic study of the operated buckets showed that aging of the alloy occurred during engine operation. Figure 17 shows typical microstructures of operated buckets. A comparison of photomicrographs of aluminized, diffusion-heat-treated as-received and operated buckets (figs. 14(b) and (d) with 17(b) and (d)) shows that appreciable aging occurred during engine operation. The greatest amount of precipitation during engine operation occurred in the aluminized air-melted buckets, group 8. Another point that may be noted from figures 14 and 17 is that the precipitates in the as-cast air-melted and vacuum-melted material behave differently during engine operation. The precipitates in the as-cast air-melted buckets, group 5, appear to have agglomerated in localized areas (fig. 17(c)). The vacuum-melted as-cast buckets, after a much greater period of engine operation, show considerably less tendency toward precipitate agglomeration.

(a) As-cast vacuum-melted group-1 bucket operated 213.5 hours.

Figure 17. - Typical microstructures of operated GMR 235 buckets.
Electrolytically etched in a 40 percent hydrochloric acid, 10 percent nitric acid, 50 percent distilled water solution; X750.

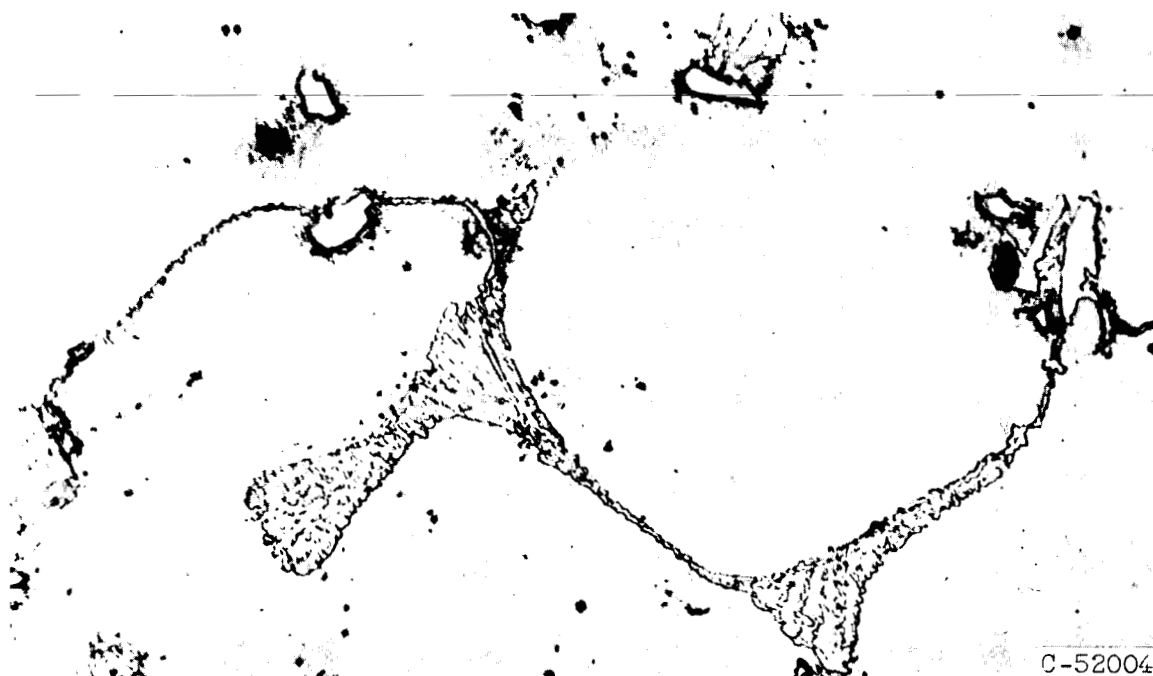
(b) Aluminized vacuum-melted group-2 bucket operated 212.5 hours.

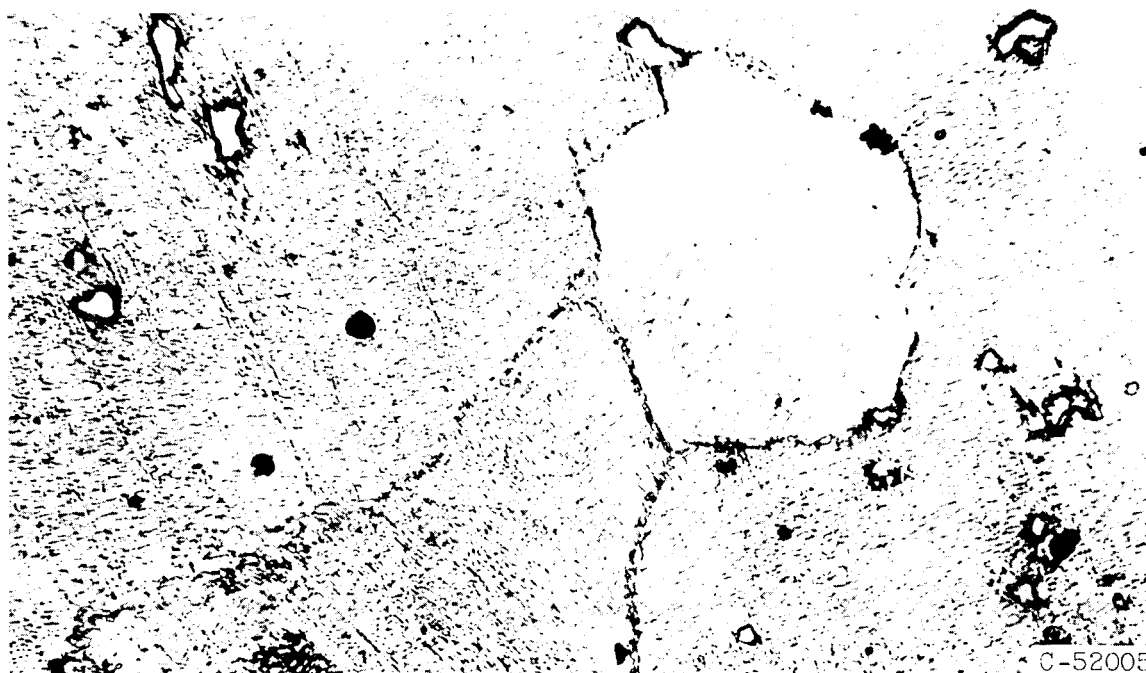
(d) Aluminized air-melted group-8 bucket operated 167.2 hours.

Figure 17. - Concluded. Typical microstructures of operated GMR 235 buckets. Electrolytically etched in a 40 percent hydrochloric acid, 10 percent nitric acid, 50 percent distilled water solution; X750.
